# Spillway/(2) Drain Pipe Culverts

**2021-CIVIL-C11**

**Tracts 447, 452 and 693**

**October 02, 2021**

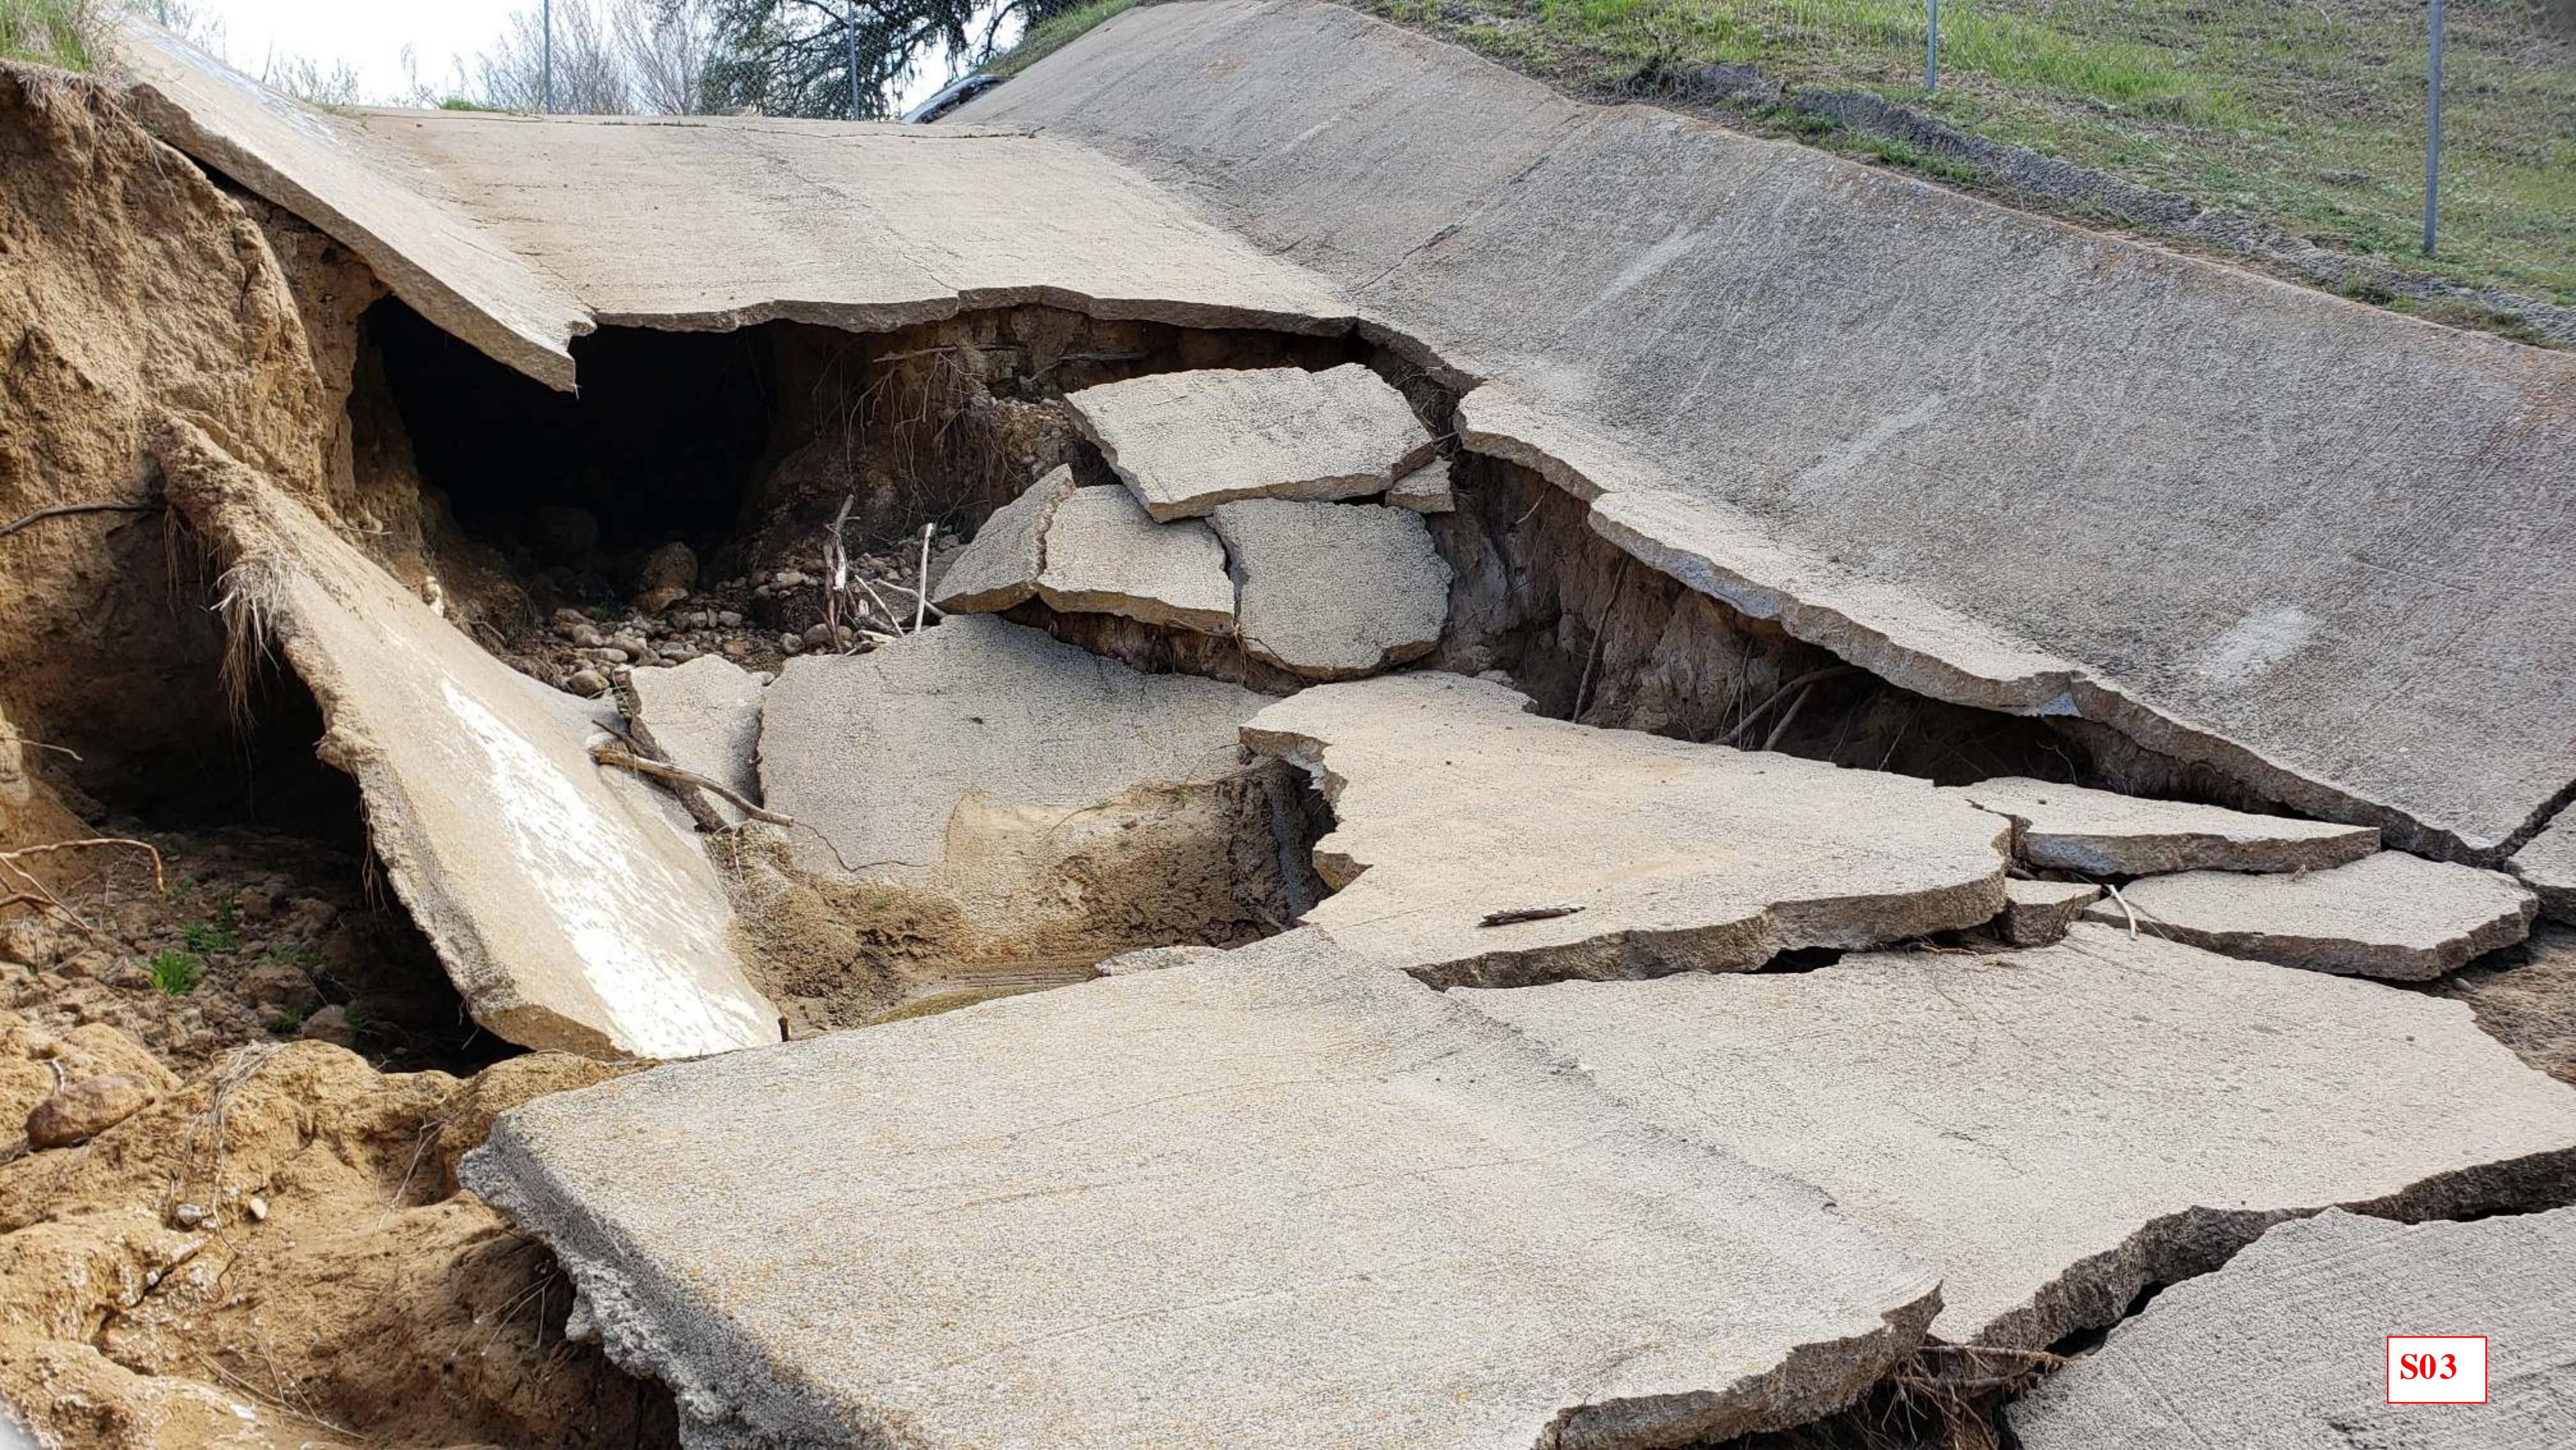
S03

Basin area in Tract 447 drains to larger basin with bigger spillway between Tracts 424 and 447.  
Condition unknown, 09.28.21, mlw

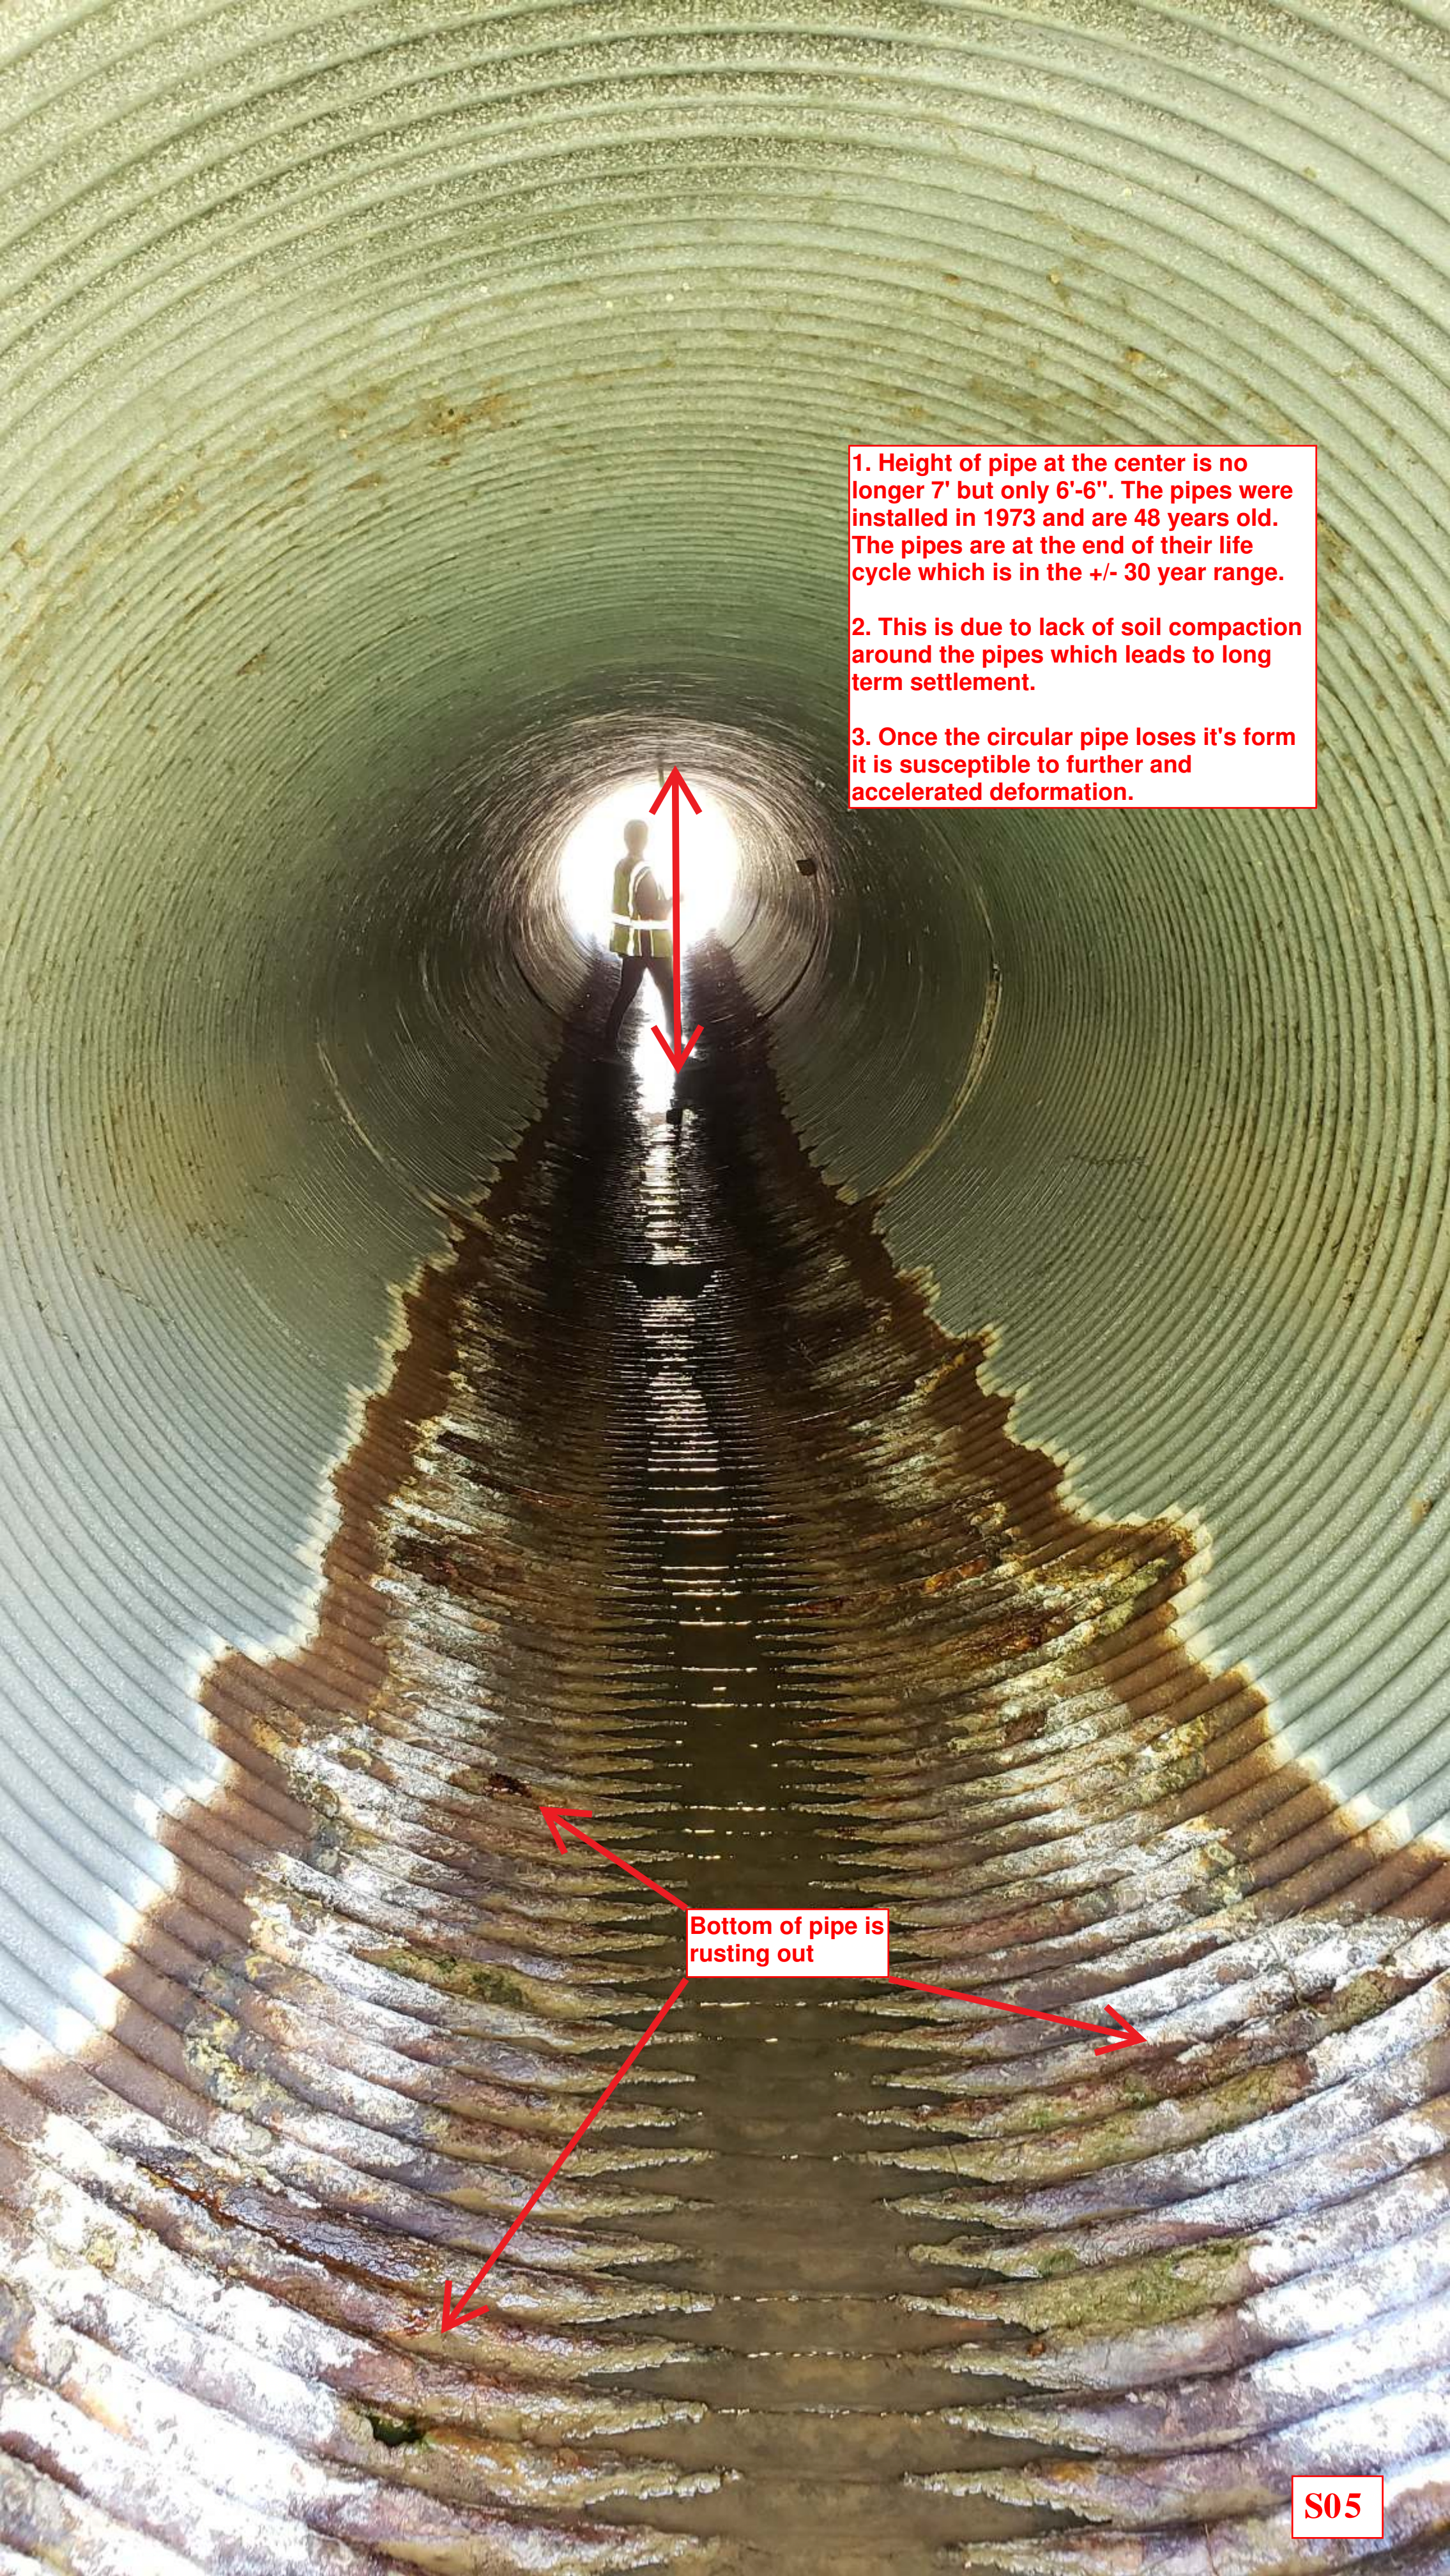
1. Height of pipe at the center is no longer 7' but only 6'-6". The pipes were installed in 1973 and are 48 years old. The pipes are at the end of their life cycle which is in the +/- 30 year range.

2. This is due to lack of soil compaction around the pipes which leads to long term settlement.

3. Once the circular pipe loses it's form it is susceptible to further and accelerated deformation.

Bottom of pipe is rusting out

Soil is being pulled through holes which will undermine the pipe even more.

Bottom of pipe is completely rusting out.

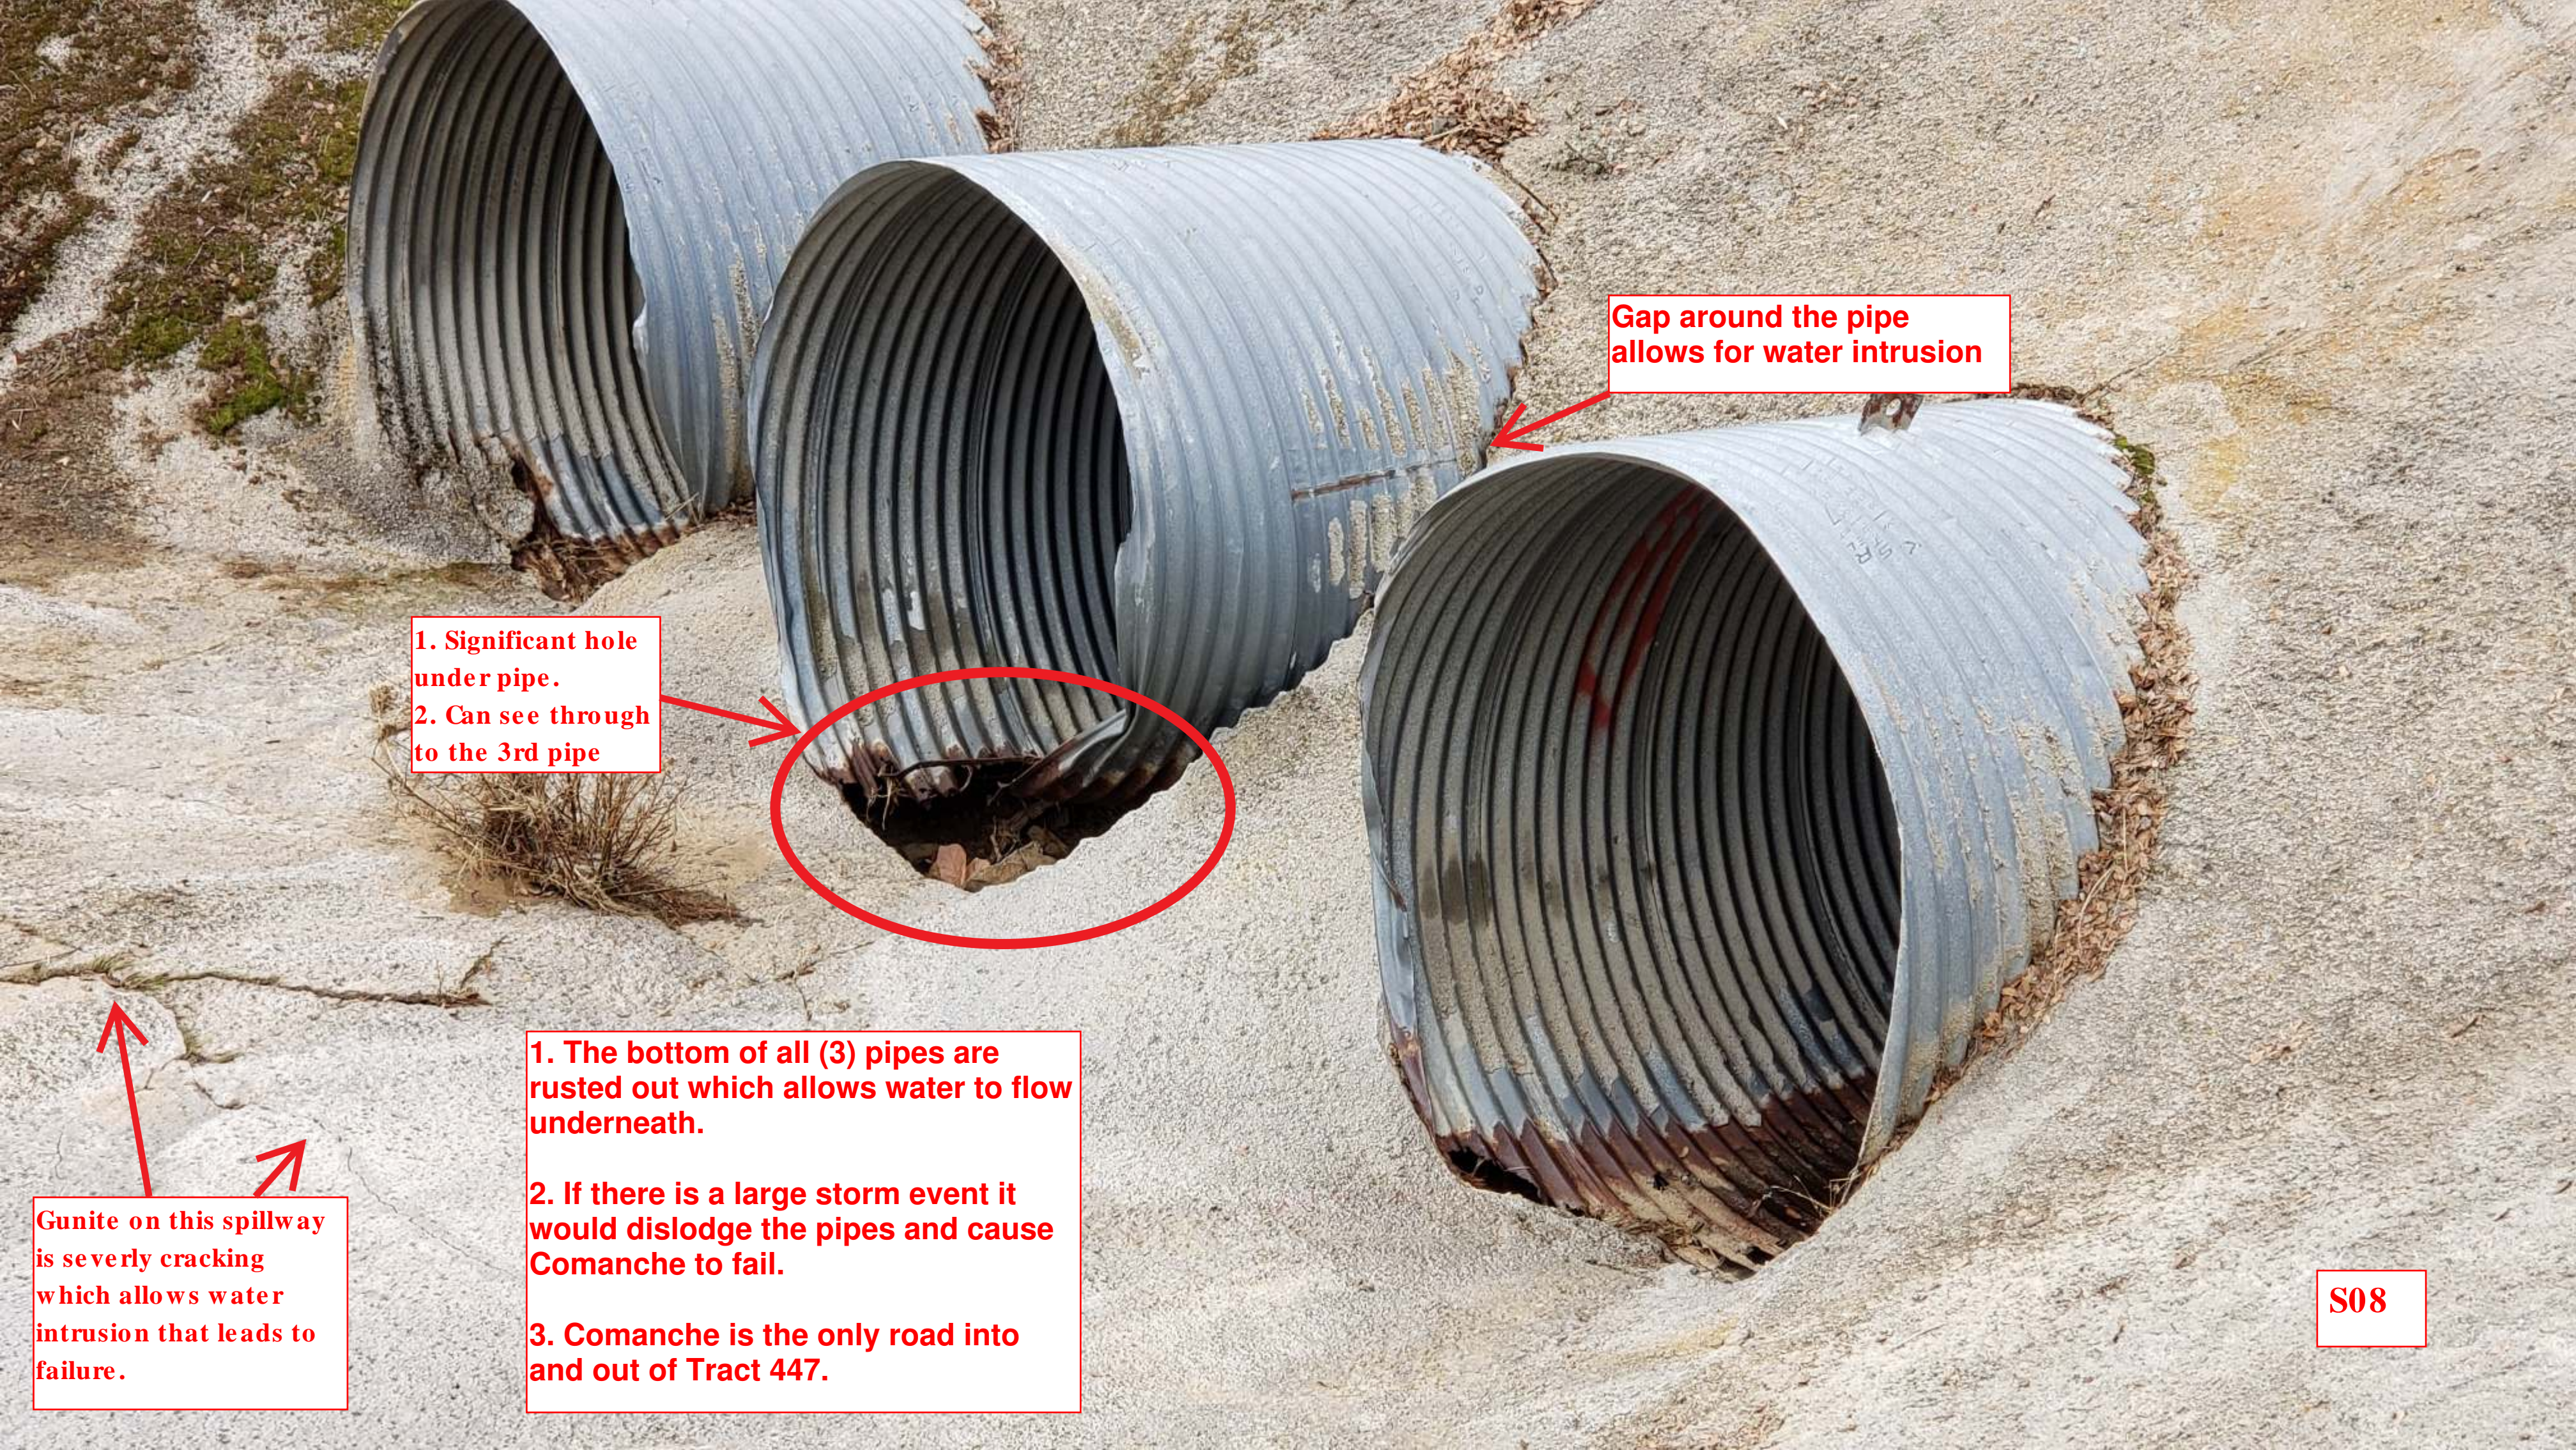
**Gap around the pipe allows for water intrusion**

**1. Significant hole under pipe.  
2. Can see through to the 3rd pipe**

**1. The bottom of all (3) pipes are rusted out which allows water to flow underneath.  
2. If there is a large storm event it would dislodge the pipes and cause Comanche to fail.  
3. Comanche is the only road into and out of Tract 447.**

**Gunite on this spillway is severely cracking which allows water intrusion that leads to failure.**

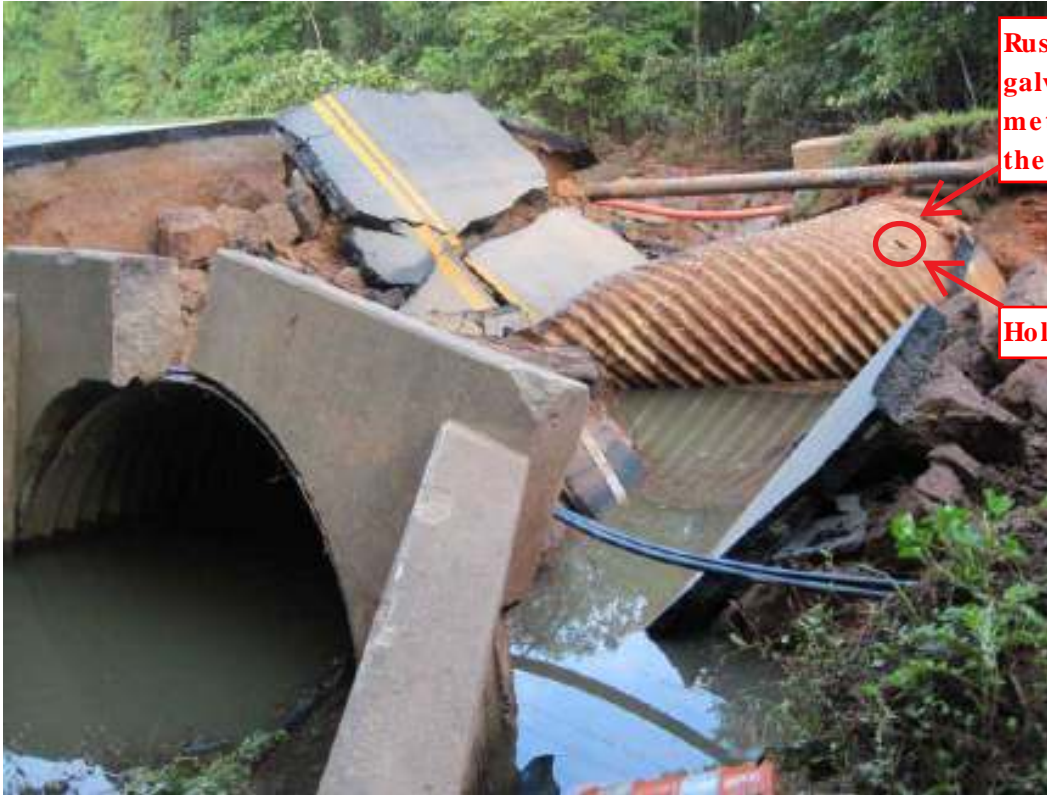
**Example of a Failed Culvert Pipe**

**Rusted and decayed galvanized corrugated metal pipe (CMP) on the outside of the pipe**

**Holes through pipe**

**Galvanized CMP's only have a lifecycle of +/- 30 years depending on soil conditions.**

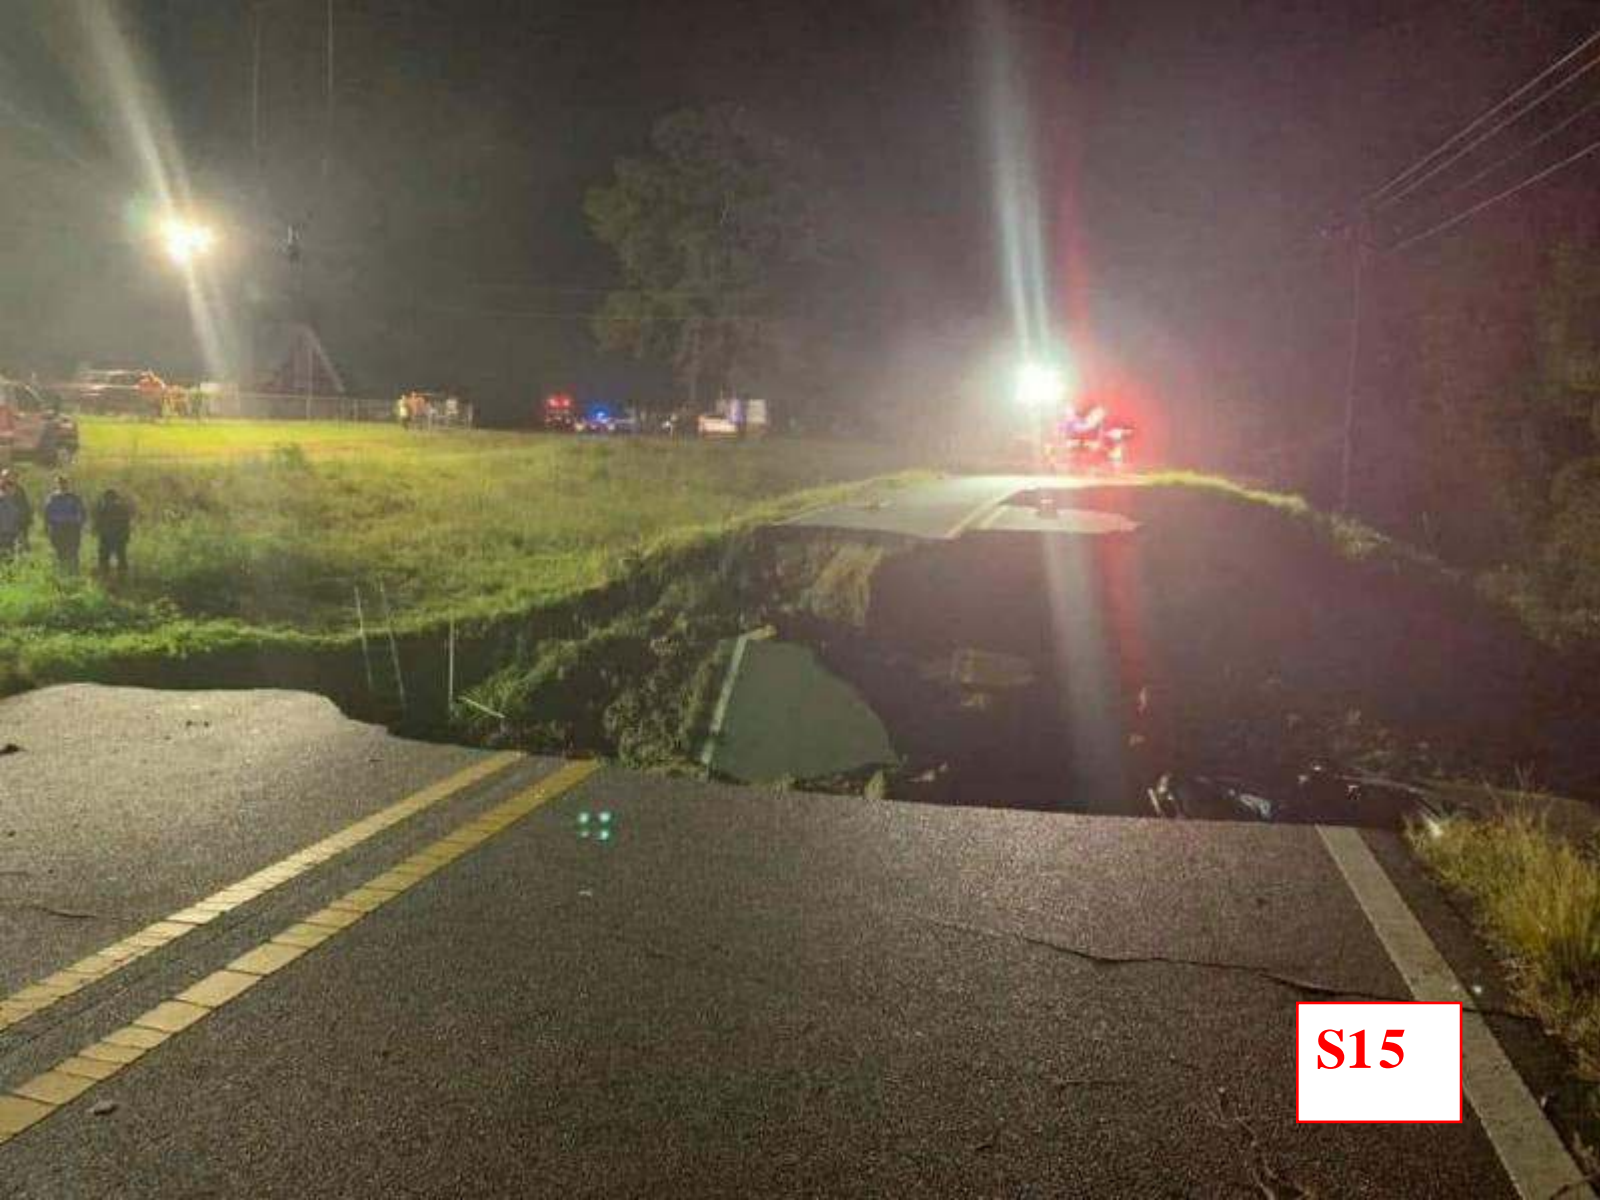
**S15**

Almost 5' from hole  
to edge of road

From the face of where the rock is supposed to be there is a 7' plus void which goes back past the 2' hole towards the road edge.
