# Spillway/(2) Drain Pipe Culverts

**2021-CIVIL-C11**

**Tracts 447, 452 and 693**

**October 02, 2021**

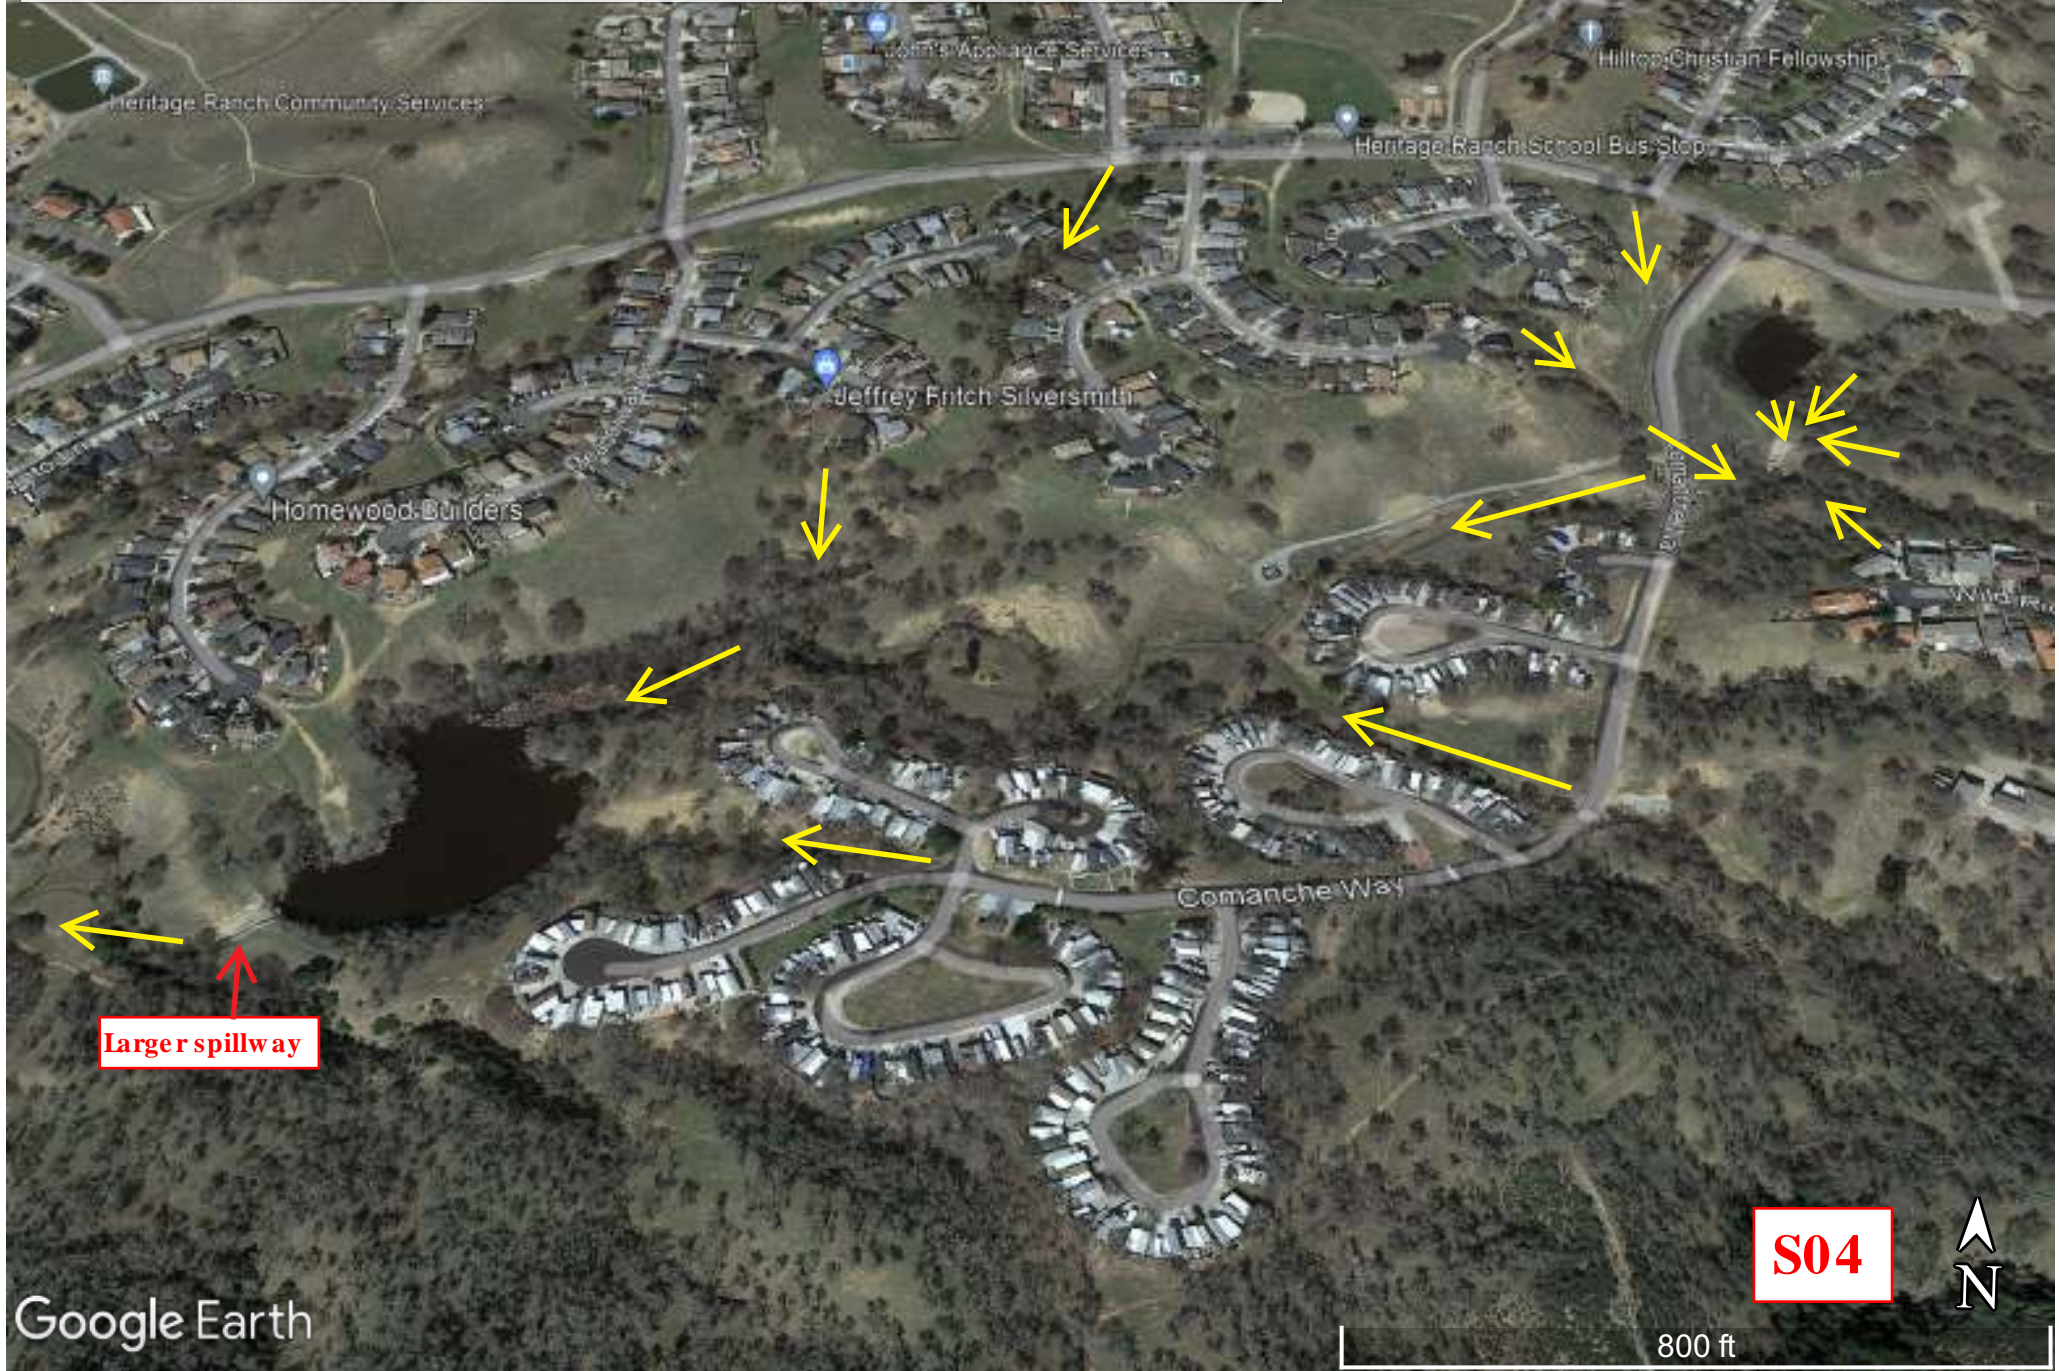
**S04**

Basin area in Tract 447 drains to larger basin with bigger spillway between Tracts 424 and 447.  
Condition unknown, 09.28.21, mlw

**larger spillway**
